Hair trigger fix

7/21/13

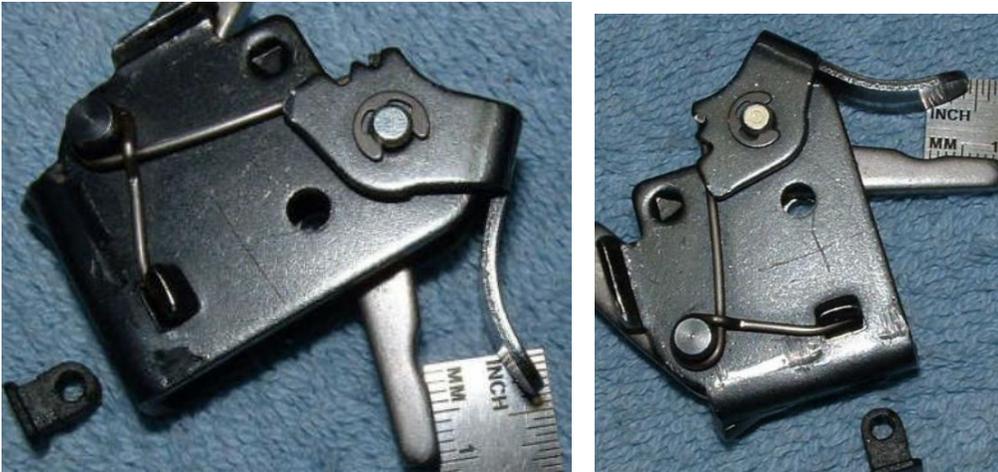
Below are two pics of the Theoben/Gamo trigger module. Your intermediate lever may not look like the ones in the pictures and may not have a notch at all but these pictures will give you an idea what the detent/notch looks like, and an approximate location where the fat pin sets relative to the intermediate lever. The location does not need to be precise and you don't want it to set it any deeper than necessary. As you can see, it is not very deep and may need to be a little deeper and wider. Trial and check as you go. It may take a couple of times to get it right.

Making it easier to work on.. On most triggers there will be a plastic insert that the original factory trigger adjustment screw screwed into in the rear of the trigger as seen in the picture. If your trigger has one these inserts, remove the adjustment screw if it is still in the insert (it should have been removed during the

installation) and pop the insert out. This will allow the intermediate lever to pop up (it is spring loaded) to be accessed and easier to worked on and without disassembling the trigger. When finished, push the lever down while reinstalling the insert. Reinstall the fat pin and trigger and reassemble the gun and test.

If it now functions properly and there is no hair trigger, it means that the intermediate lever is not notched or the notch is not deep enough or maybe not wide enough. You will need to file or use a Dremel Tool to make or increase the notch depth a little deeper (several thousandths) as well as a little wider where the fat pin, as it sets in the trigger, makes contact with the intermediate lever.

To determine where the notch should be, with the GRT-III trigger removed, look in the long slot that the fat pin extension moves up and down in on the side of the trigger block and you will see the intermediate lever. You can mark the lever with a pencil or fine tip Magic Marker to determine where the notch should be.
