Crosman Titan GP Trigger

By Charlie 8/12/11

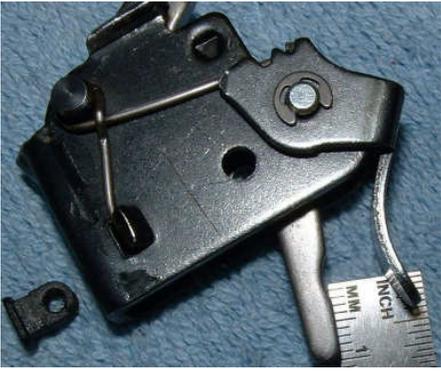
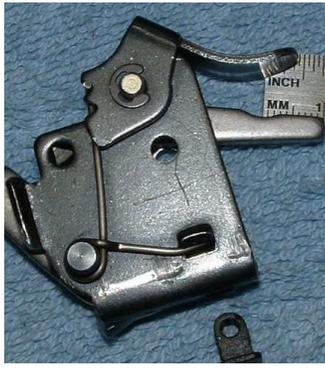
Below are two pics of the Theoben/Gamo trigger module. Your intermediate lever will not look like the ones in the pictures. If they did, there wouldn't be this issue...lol... I don't have any pics of the Crosman and Benji intermediate levers but these pictures will give you an idea what the detent/notch looks like, and an approximate location where the fat pin sets relative to the intermediate lever. The location does not need to be precise but you don't want it to set any deeper than necessary. As you can see, it is not very deep.

On some triggers there will be a plastic insert that the original factory trigger adjustment screw screwed into in the rear of the trigger as seen in the picture. If your trigger has one these inserts, remove the adjustment screw if it is still in the insert and pop the insert out. This will allow the intermediate lever to pop up (it is spring loaded) to be accessed and worked on without disassembling the trigger as seen in the picture.

I made a suggestion to some of the guys to mark where the fat pin comes in contact with the intermediate lever and then file a small indentation about 1/16 inch or so deep at that point for the fat pin to set in using a Dremel Tool or a round file. A simple fix and it did resolve the problem and may also increase the second stage feel.
